Attention Service Manager/Parts Department

Subject: BOOST Flex Plate, Bearing Shield & Isolator Replacement – **Revised to reflect change in 20" Upper Isolator and Nut, and further improvements to the Flex Plate mounting. Refer to TSBCL2010-21**

Models Affected: BOOST 28
BOOST 32 (05312K, 05313K)
Focus BOOST Rider (00344K)
Focus II BOOST L20 (05370A-S)
Focus II MID-SIZE BOOST 28 & 32

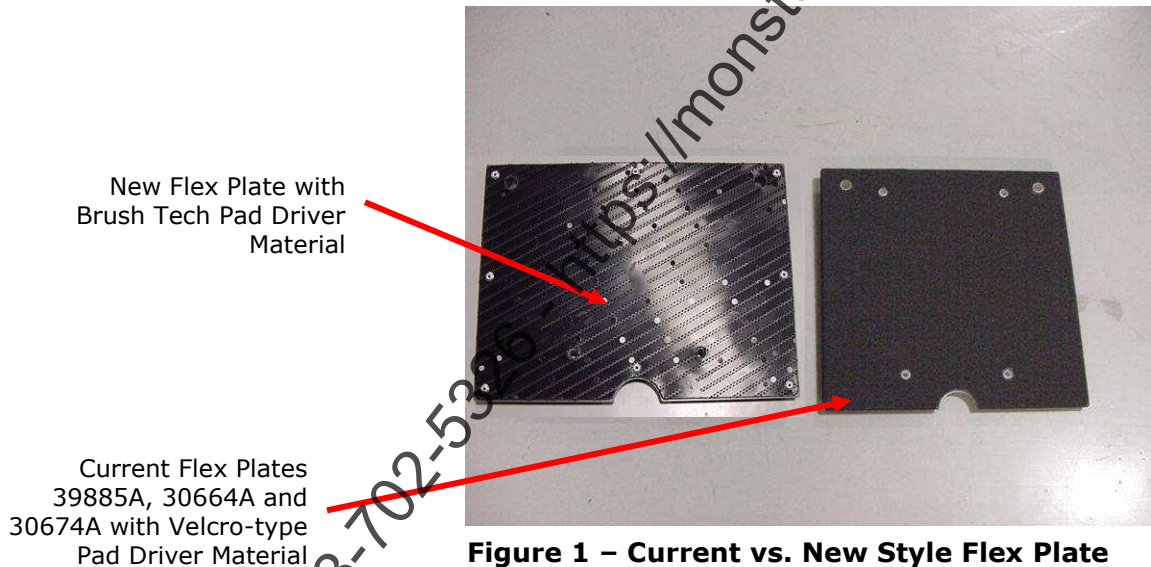
Thicker material allows use of rivets to improve connection between Pad Driver Material and Flex Plate.

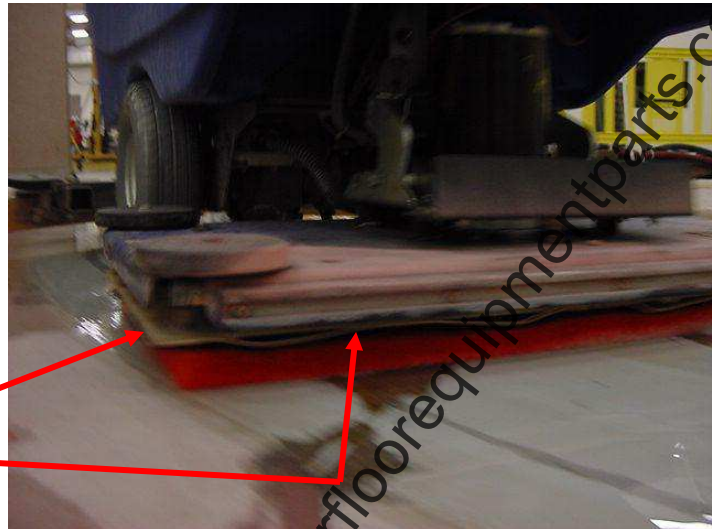
Figure 3 – Adhesive on New Flex Plate

Under certain conditions the adhesive on the new Flex Plate may break down and release along the edges, but this does not affect functionality. The additional rivet fastening maintains integrity and keeps the Pad Driver Material secured to the Flex Plate.

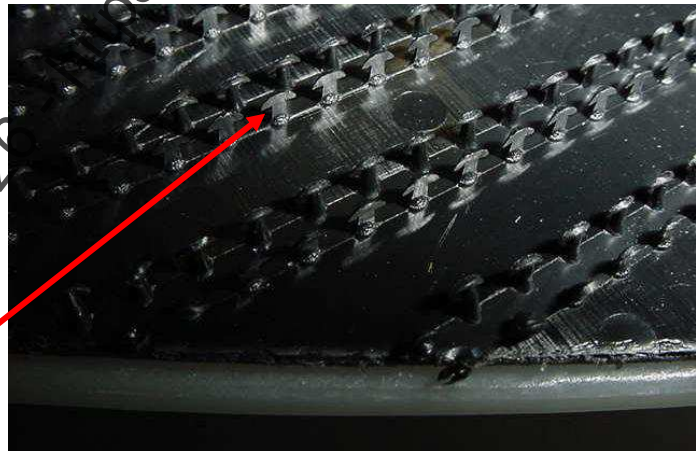
Figure 4 – Molded-in Hooks in New Driver Material

New Pad Driver Material has molded-in hooks to improve pad retention.

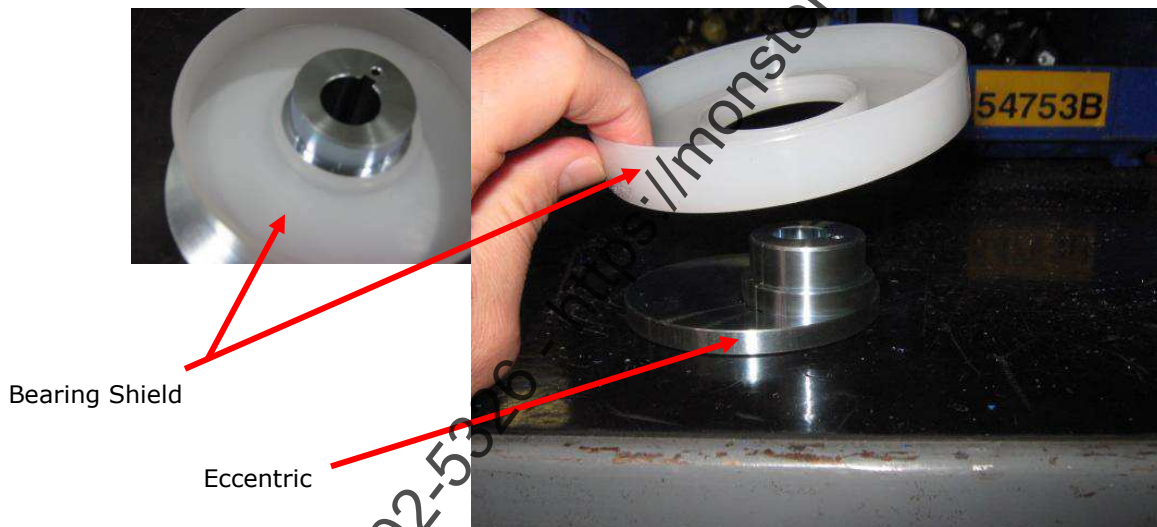
Figure 6 - Bearing Shield Assembly

2. Shortened bearing life:
 - a. The bearing shield can come loose, exposing the bearing to water. This exposure can eventually result in moisture working its way into the bearing, causing bearing wear or even eventually causing the bearing to seize.

- b. Mechanically securing the pad driver material via rivets
2. The bearing assembly was updated with the following changes:
 - a. Using an improved molded plastic bearing shield to deflect water away from the bearing. The new bearing shield uses a significantly more durable material and a tighter assembly fit for better retention and durability than the previous version.

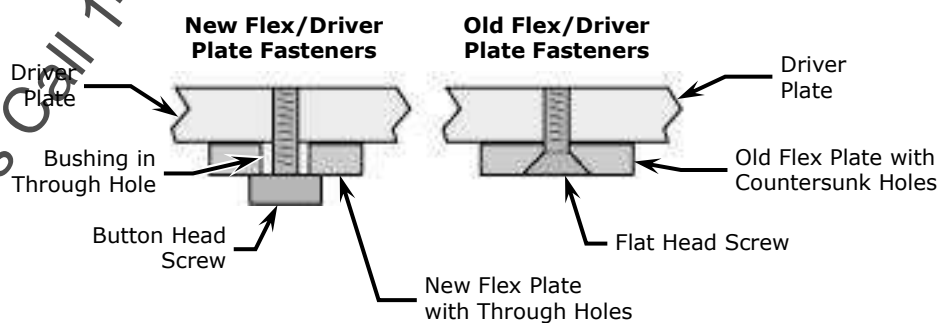
Figure 9 - New Flex Plate Mounting Hardware

4. Vibration results in wear between the flex plate and screw head.

See Figure 9. Socket Head Screws have replaced the tapered Flat Head Screws securing the Flex Plate to the Driver Plate. Through Holes with Bushings have replaced the Countersunk Holes in the Flex Plate.

Note: Use Loctite® 242 and torque to 40 in-lbs.

Note: If you order a new Flex Plate, you'll need to order new fasteners:

- Flex Plate Bushing, p/n 560380173
- #10-32 x .62 Button Head Socket Screw, SS, p/n 56003825
