Attention Service Manager/Parts Department

Subject: BOOST Flex Plate, Bearing Shield & Isolator Replacement – **Revised to reflect change in 20" Upper Isolator and Nut, and further improvements to the Flex Plate mounting. Refer to TSBCL2010-21**

Models Affected: BOOST 28
BOOST 32 (05312K, 05313K)
Focus BOOST Rider (00344K)
Focus II BOOST L20 (05370A-S)
Focus II MID-SIZE BOOST 28 & 32

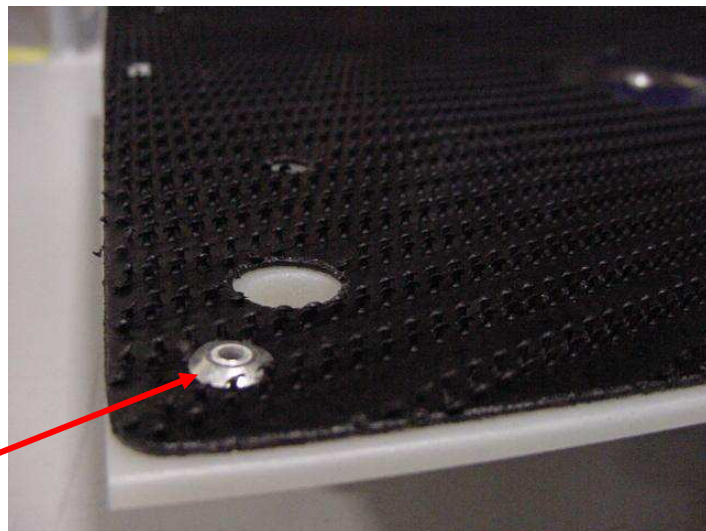
Thicker material allows use of rivets to improve connection between Pad Driver Material and Flex Plate.

Under certain conditions the adhesive on the new Flex Plate may break down and release along the edges, but this does not affect functionality. The additional rivet fastening maintains integrity and keeps the Pad Driver Material secured to the Flex Plate.
